OUT-OF-PHASE INDICATION FROM DESCENT ENGINE
PROPELLANT SHUTOFF VALVES

(NASA-TM-X-70004) OUT-OF-PHASE INDICATION
FROM DESCENT ENGINE PROPELLANT SHUT OFF
VALVES (NASA) 12 p

MANNED SPACECRAFT CENTER

JANUARY 1969

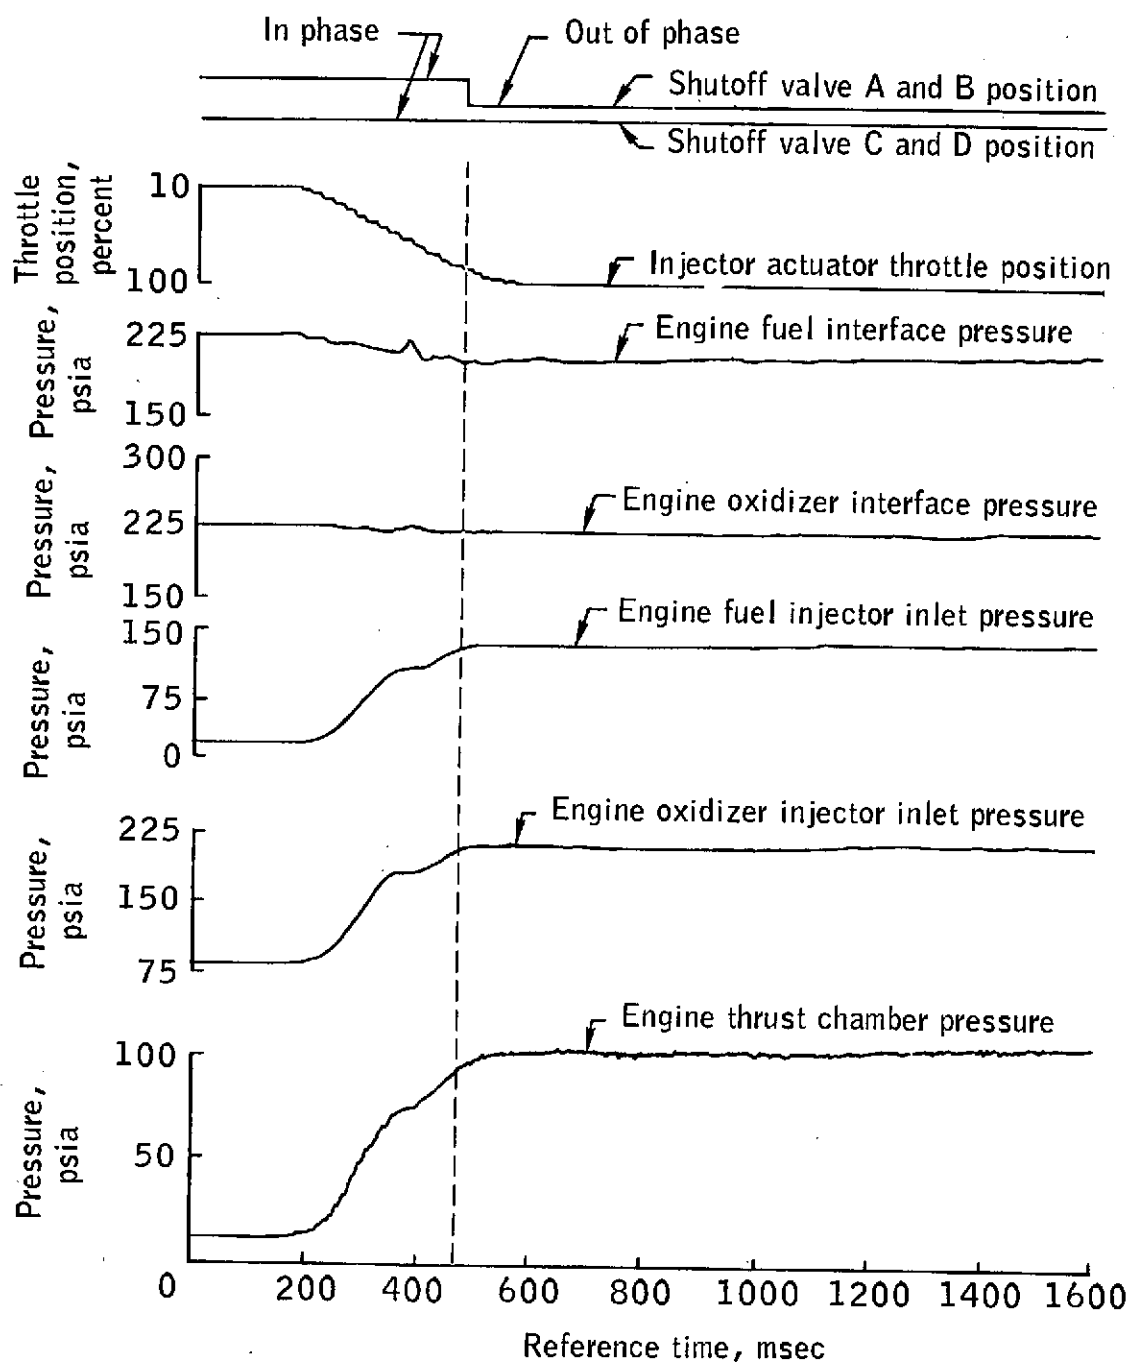
Figure 1.- Descent propulsion parameters during transition from 10-percent throttle to full throttle. (Typical of second and third firings).

The engine pressures responded properly to the throttle command until, at approximately 70-percent chamber pressure, a plateau was noted in the indications of both injector pressures and chamber pressure (see fig. 1). Also, increases were noted in the oxidizer and fuel interface pressures. The out-of-phase signal could indicate that either the instrumentation malfunctioned or that one or two of the shutoff ball valves in the propulsion system moved from the open position.

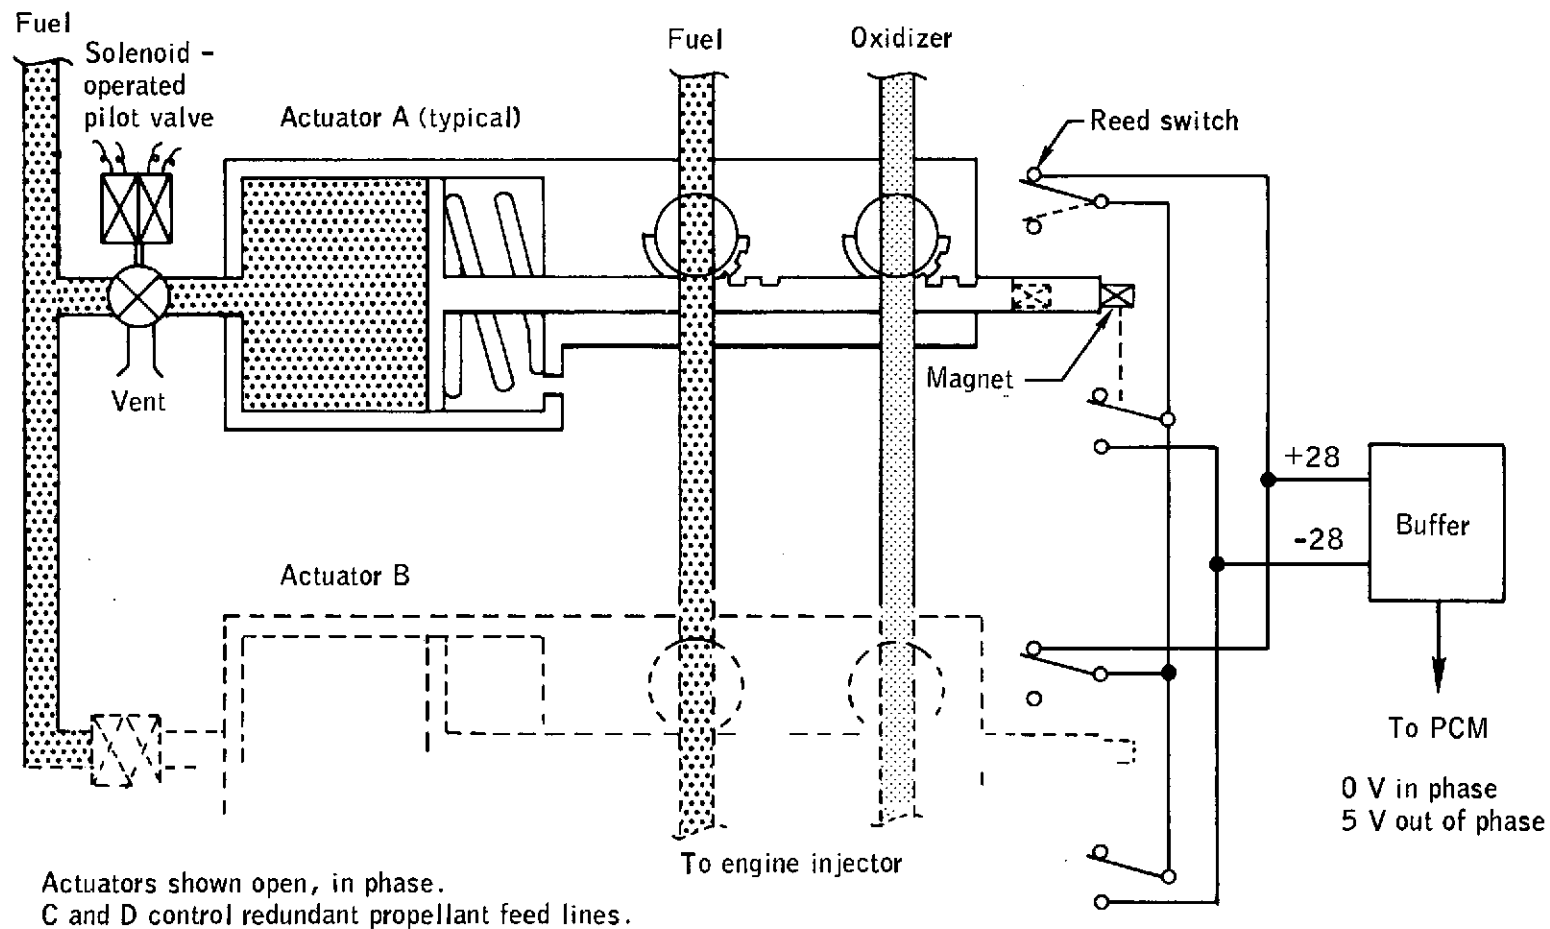
Figure 2.- Ball shutoff valves.

A schematic of the shutoff ball valve system is shown in figure 2. The phase monitor consists of eight reed switches divided into two sets of four (A/B and C/D). Each set is wired into a bilevel event measurement which indicates whether the two actuators in each pair are both open or both closed. During the anomaly, the A/B event measurement changed state, indicating that one or two valves had moved from the open position, with the following possibilities:

- a. One moved and could have closed completely.
- b. Two moved, and one could have closed completely.

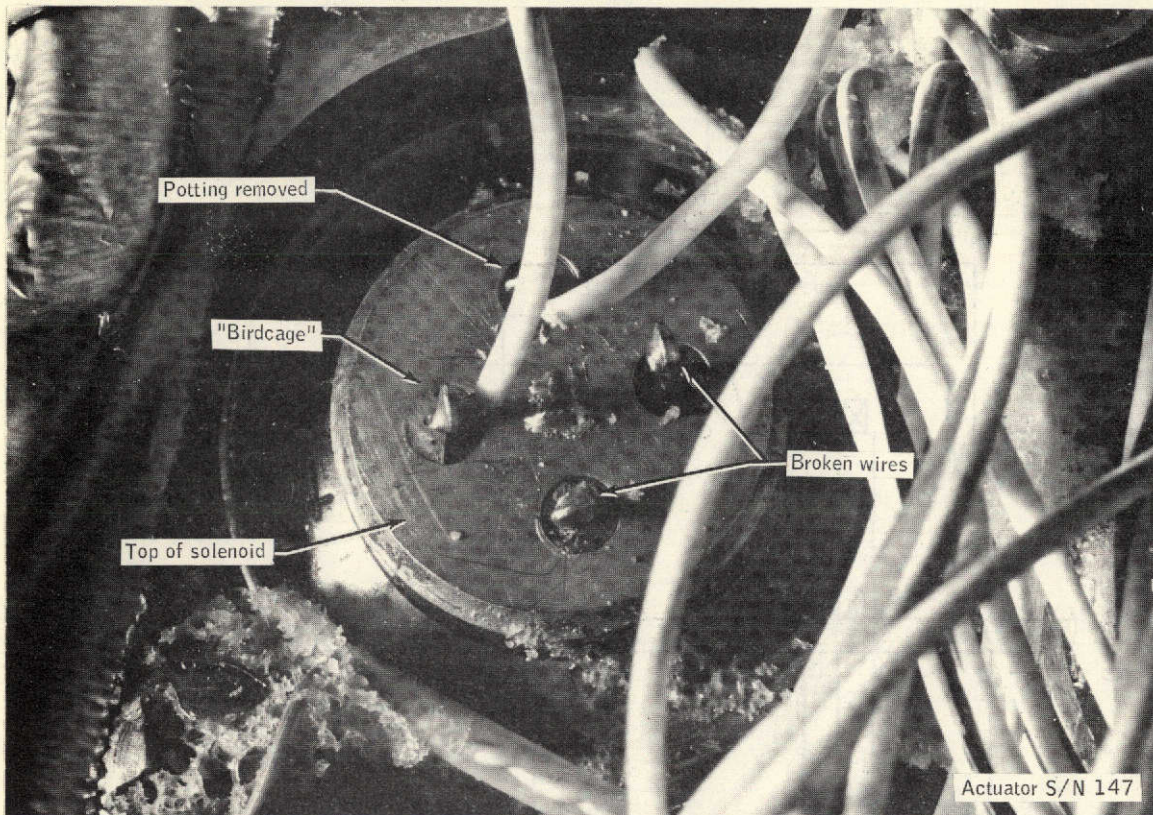
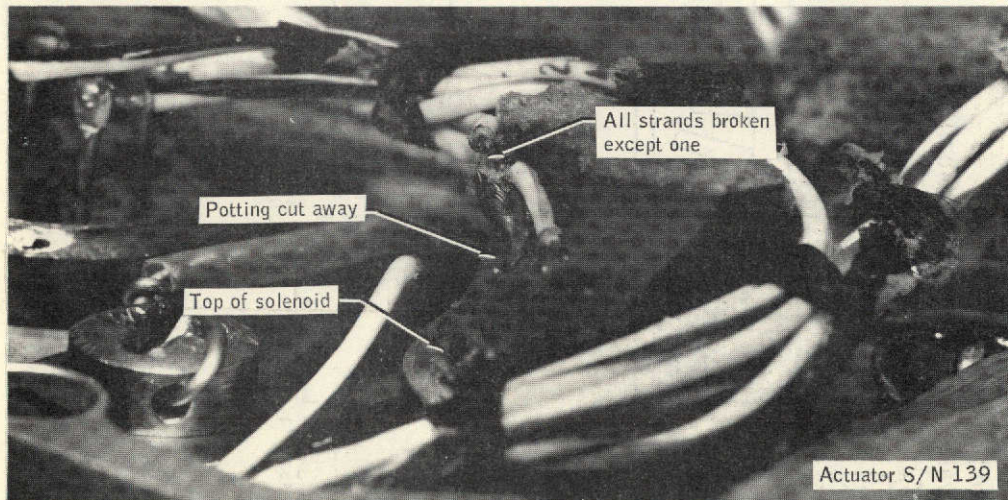
Figure 4.- Quality control problems at wiring interface with solenoid valve actuator.

A quality control problem, consisting of "birdcaging," poor solder joints, broken strands, and in one case a completely broken lead (fig. 4), was discovered in the wiring of some solenoid pilot valves. As a result of these discoveries, the solenoids were replaced on LM-3 and LM-4. The LM-1 solenoids were not inspected. Consequently, the conditions mentioned above may have existed.

Inspections and quality control procedures have been given added emphasis. The valve packages on LM-3 and LM-4 have been replaced with packages with improved workmanship and techniques on the terminal connectors. These improved techniques have been implemented on subsequent engines during assembly at the vendor's plant.

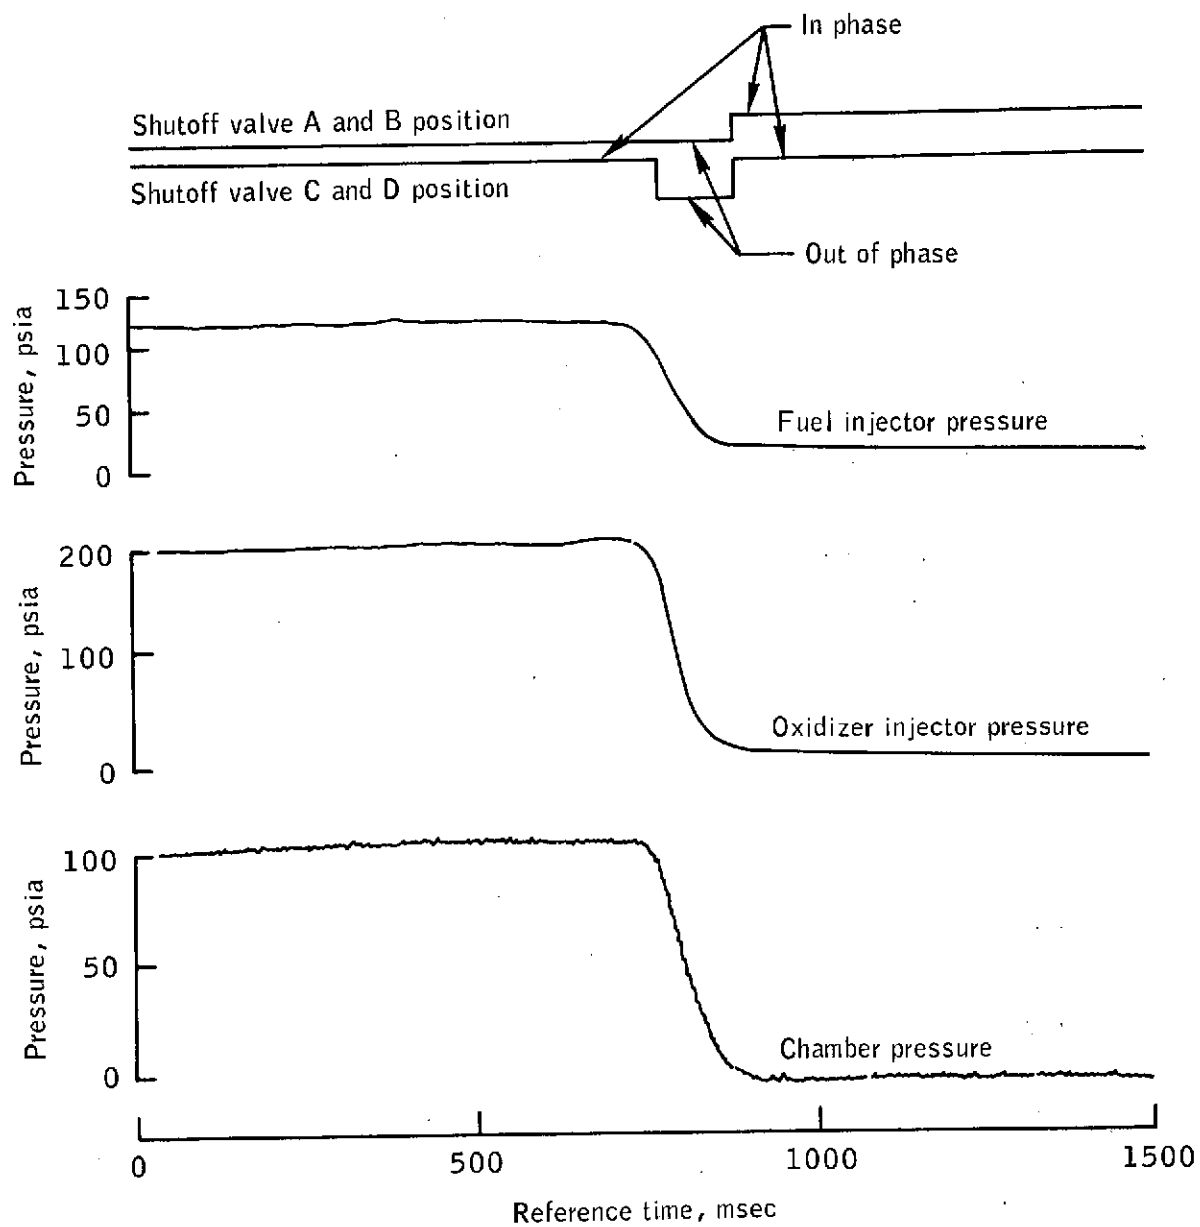
Figure 3.- Descent propulsion parameters during shutdown.
(Typical of second and third firings).

The investigation disclosed that the reed switch was an unreliable device and was subject to installation problems that could cause malfunctions. However, none of the malfunctions were like the out-of-phase indication during the Apollo 5 mission. Most previous malfunctions had been failure of a valve-open indicator switch to change state when the valve was initially opened. However, this type of failure can be discounted as a cause of the anomaly, since the proper phase indication was received during the 10-percent thrust portion of all three firings and after the valves were closed (fig. 3). Further, the time from first movement of the throttle control to change of the phase indication was 299 and 291 milliseconds for the second and third firings, respectively; this repeatability demonstrates that the instrumentation indications were quite consistent.

The phasing monitor has been eliminated from LM-5 and subsequent vehicles.

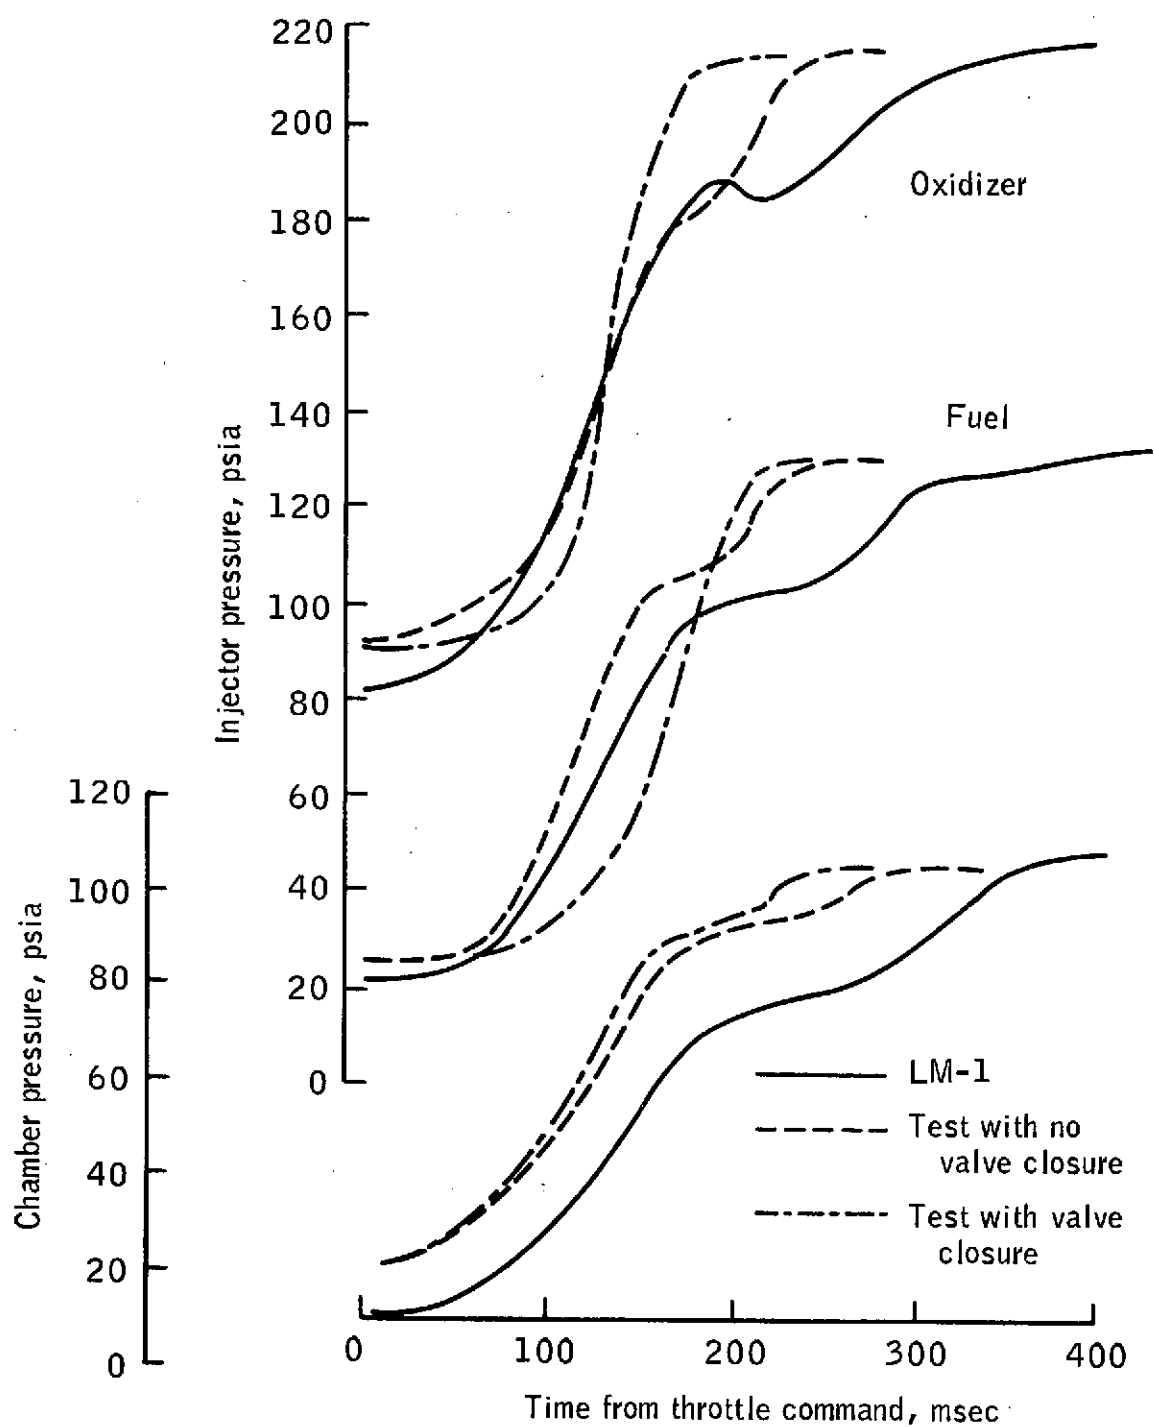
Figure 5.- Pressures during flight and ground tests.

Tests using helium-saturated propellants were conducted to determine how a valve closure during the throttle-up transient would affect chamber, injector, and interface pressures. The interface pressure did not rise, and while some plateaus in the chamber pressure were noted, they were not caused by a valve closure. The pressure transient from the Apollo 5 mission is compared with the test series in figure 5.
